Mill Creek

Flood Control Project
Radial Gate Investigations

US Army Corps of Engineers, Walla Walla District

HDR Engineering, Inc.

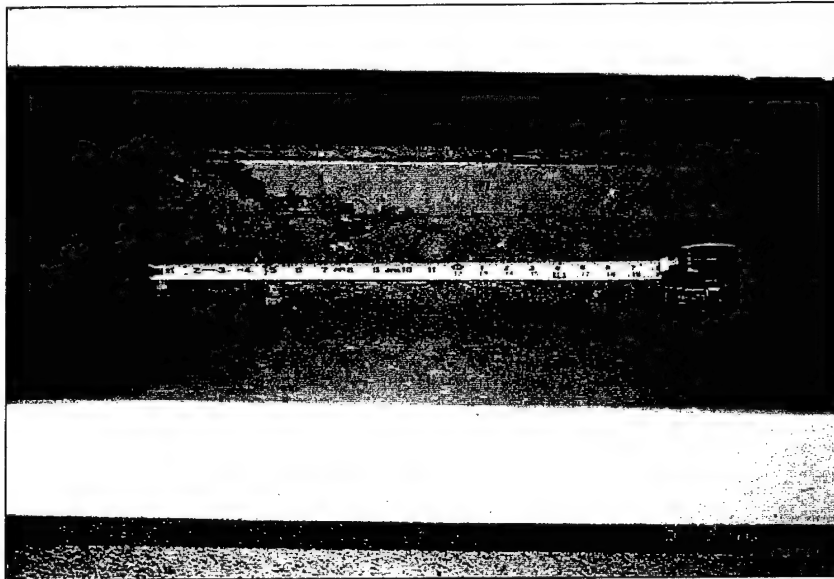
channel at approximately 6-inches on-center, however, there are bolts at only every other hole. See photos 5 and 6, below. Note: The 6-inch spacing matches that of the connections to the skin plate. Since the spacing of the bolts is not indicated on the plans, it is not known if the holes were intended for bolts to fasten the bumper to the channel or if the holes are intended for drainage. The holes are not continued through the timber bumper and are consistently clogged with debris at the girder web.

Photo 5- Debris and clogged holes on bottom channel (typ).

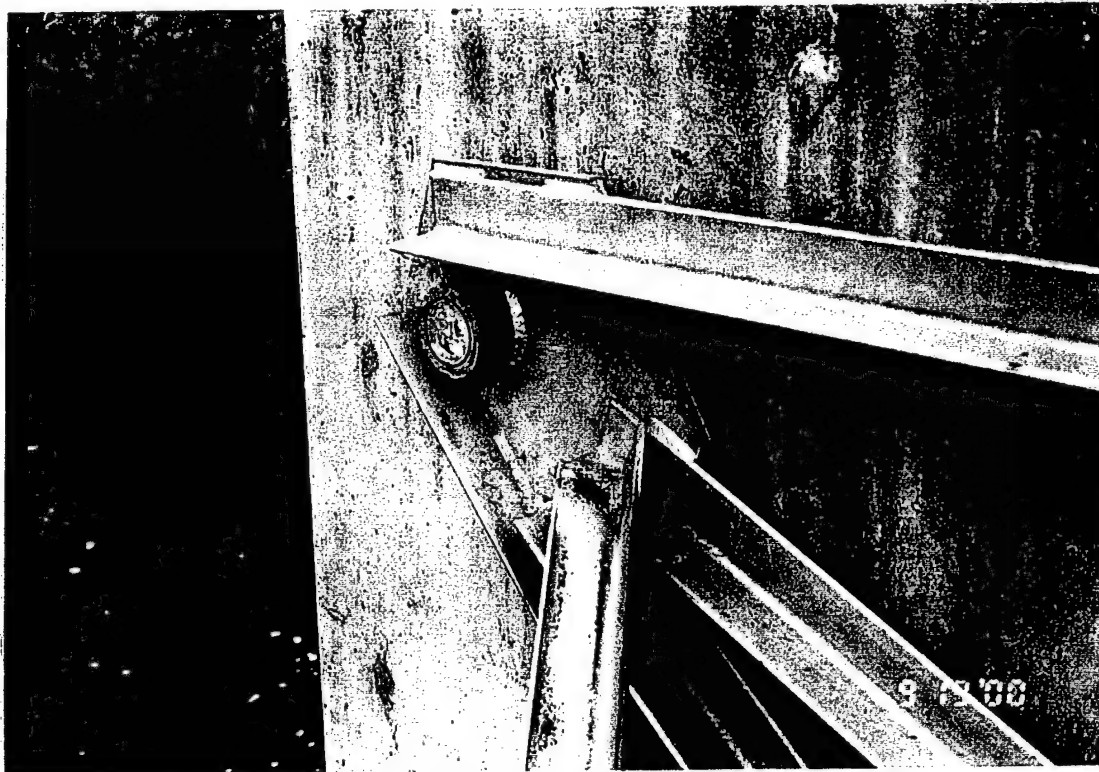
1-6

Armco 6'x14' Gate
Right trunnion. Light surface
corrosion on diagonal brace and
trunnion bushing.

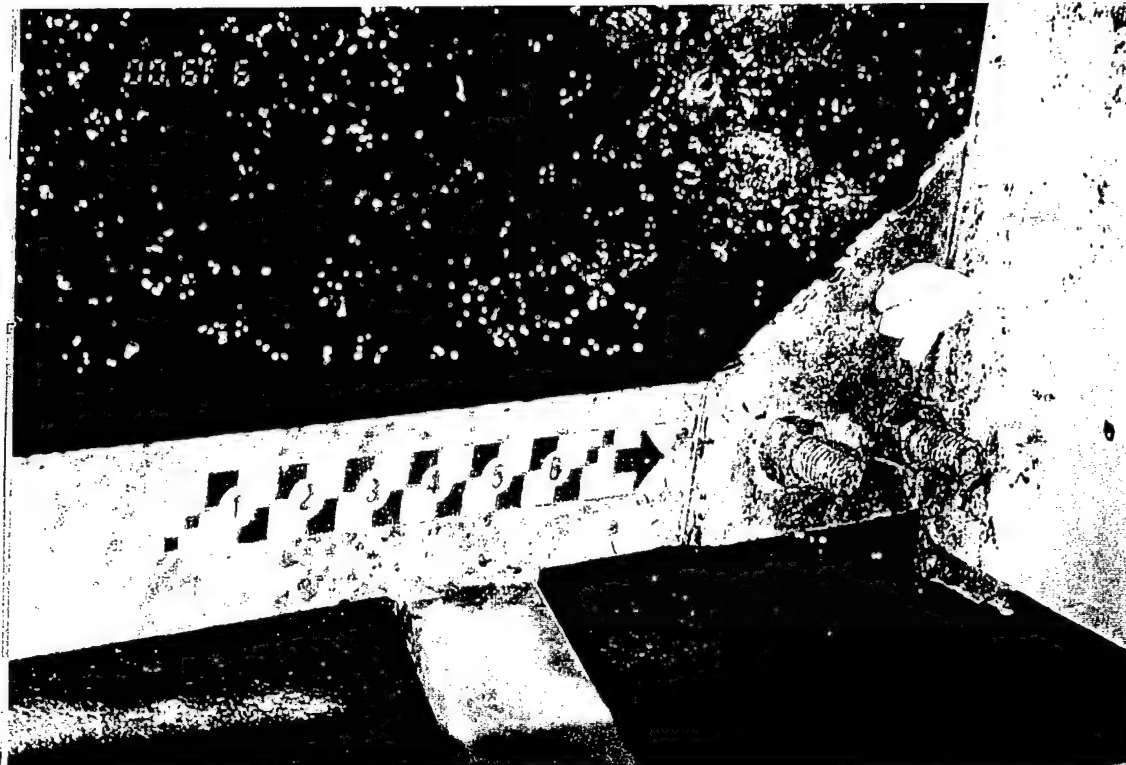
Mill Creek Dam 9/19/00 1-11	Armco 6'x14' Gate Bottom upstream end Strut 1, left side of gate. Light corrosion on gusset plate and bolts.
---	--

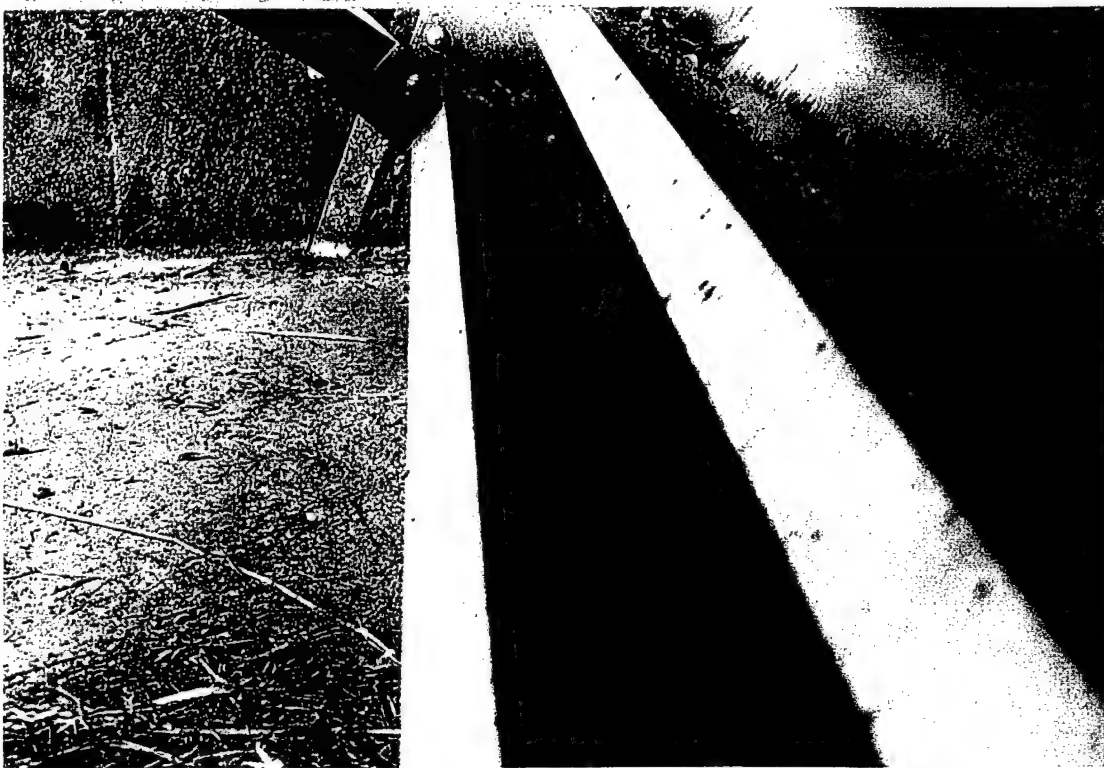
Gate 1 - 8'x18'
Inside of bottom horizontal girder
looking toward right frame. Debris
and evidence of standing water on
girder web and skin plate.

- Drainage holes should be provided for the horizontal girders which are rotated to cause ponding against the skin plate. The drain holes should be 1-inch in diameter and spaced at approximately 24-inches along the girders. The edge of hole should be located approximately 1/2-inch from the girder flange. The holes should be drilled, not flame cut (the use of a mag-drill is recommended). If flame cut holes are the only available option, the edges of the holes should be reamed smooth.

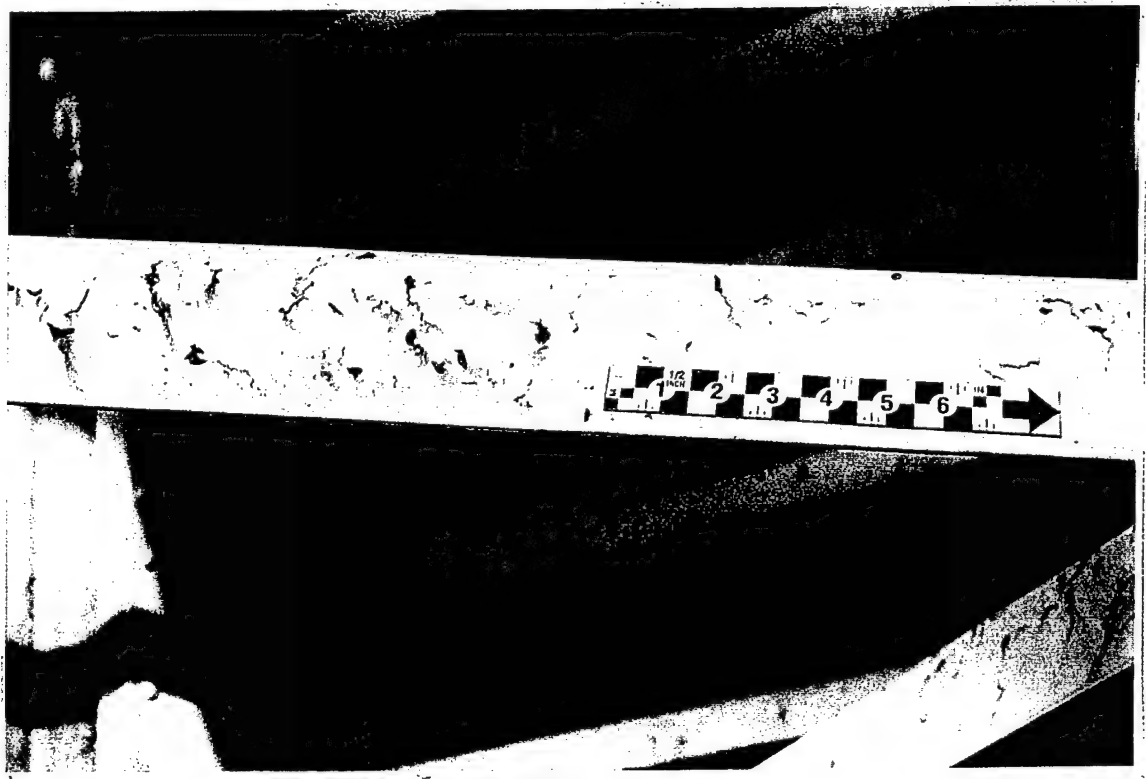
Gate 2 - 8'x18'
Paint peeling, delamination and light
corrosion on cross bracing, typical.

- The exposed metal edges of the new drain holes should be spot painted.
- Spot waterblast cleaning and painting should be performed at locations of light to moderate corrosion.

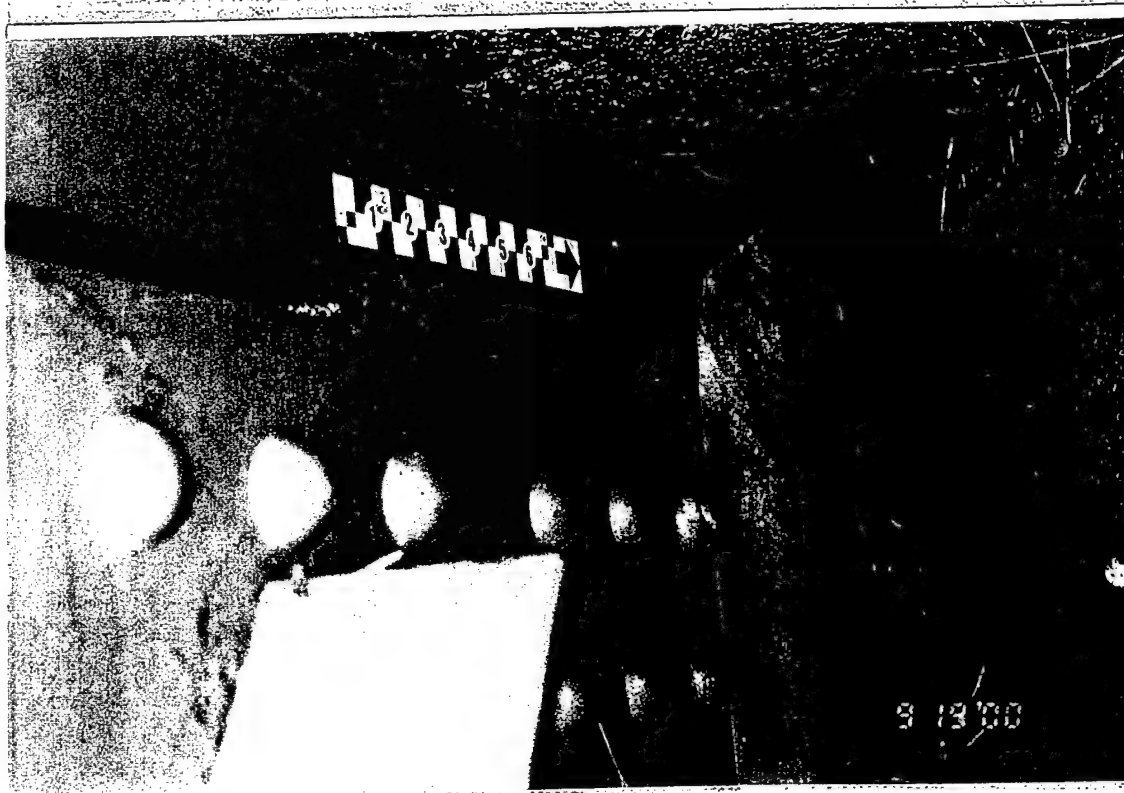
2-3

Gate 2 - 8'x18'
Bottom left side of gate at timber
bumper. Splitting at end of bumper.

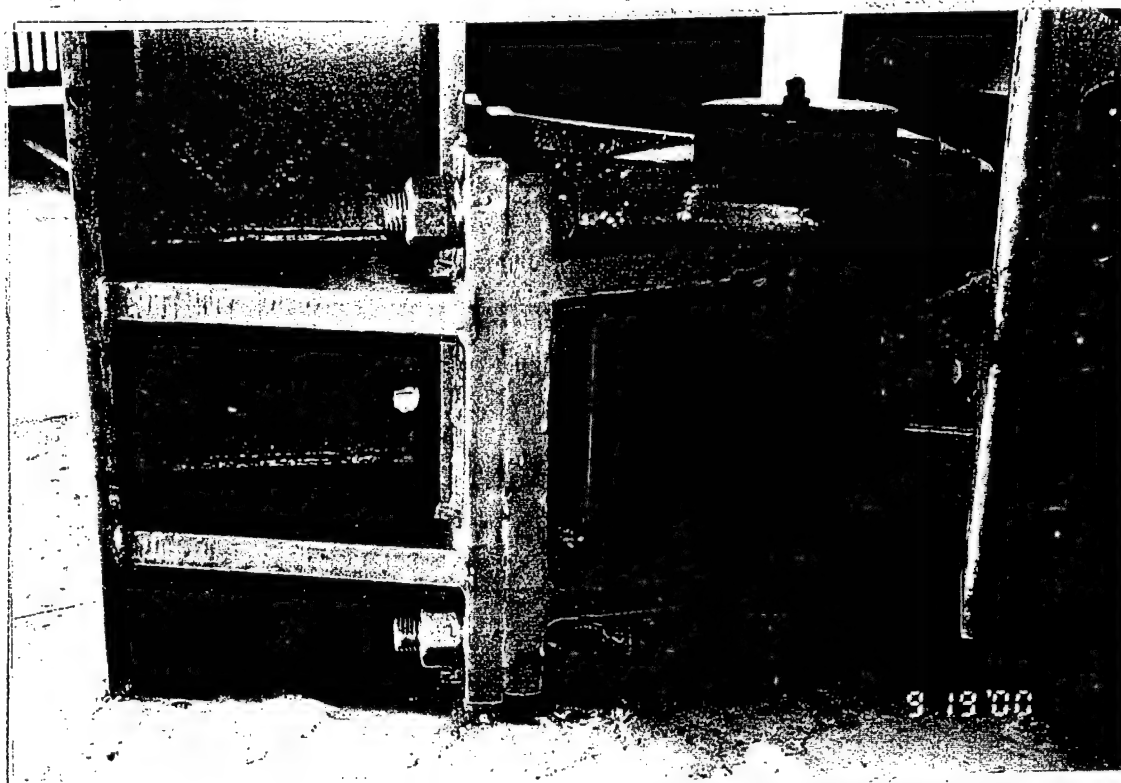
Mill
Creek
Dam
9/19/00
2-5

Gate 2 - 8'x18'
Top web of bottom horizontal girder.
Debris and clogged drain holes,
typical.

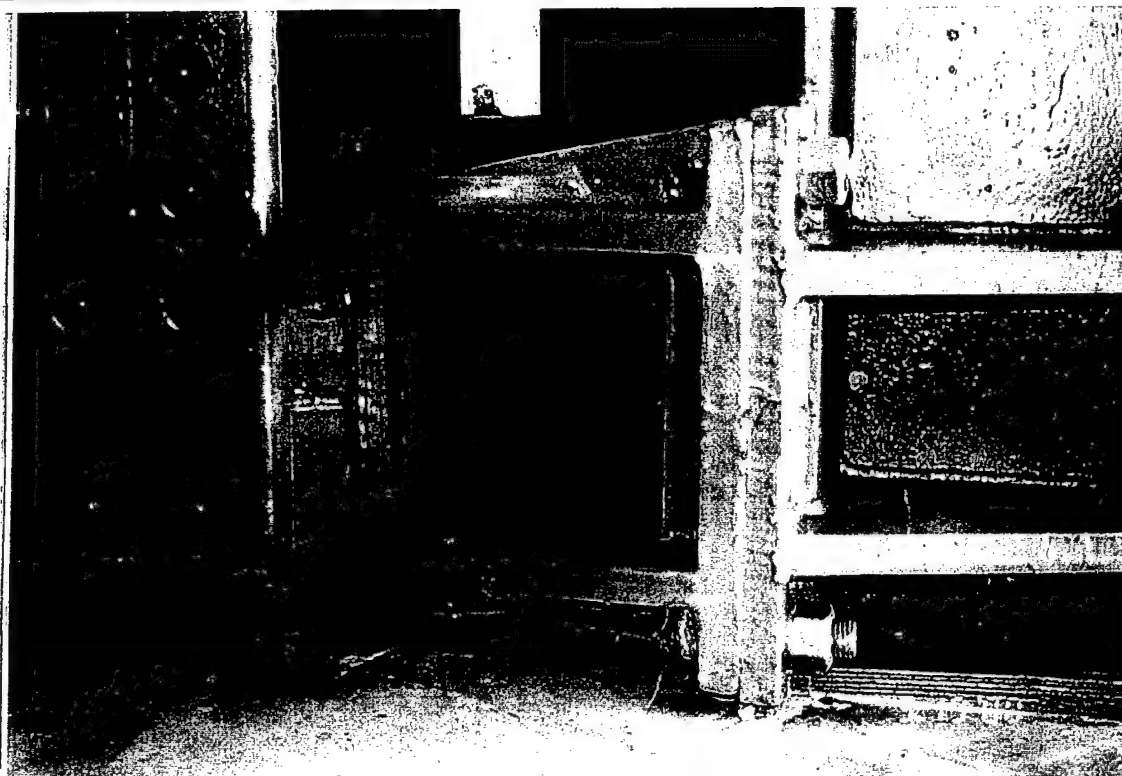
Mill
Creek
Dam
9/19/00
2-6

Gate 2 - 8'x18'
Bottom of right trunnion and trunnion
beam. Note: lubrication fitting on
trunnion pin and lubrication between
trunnion and yoke.

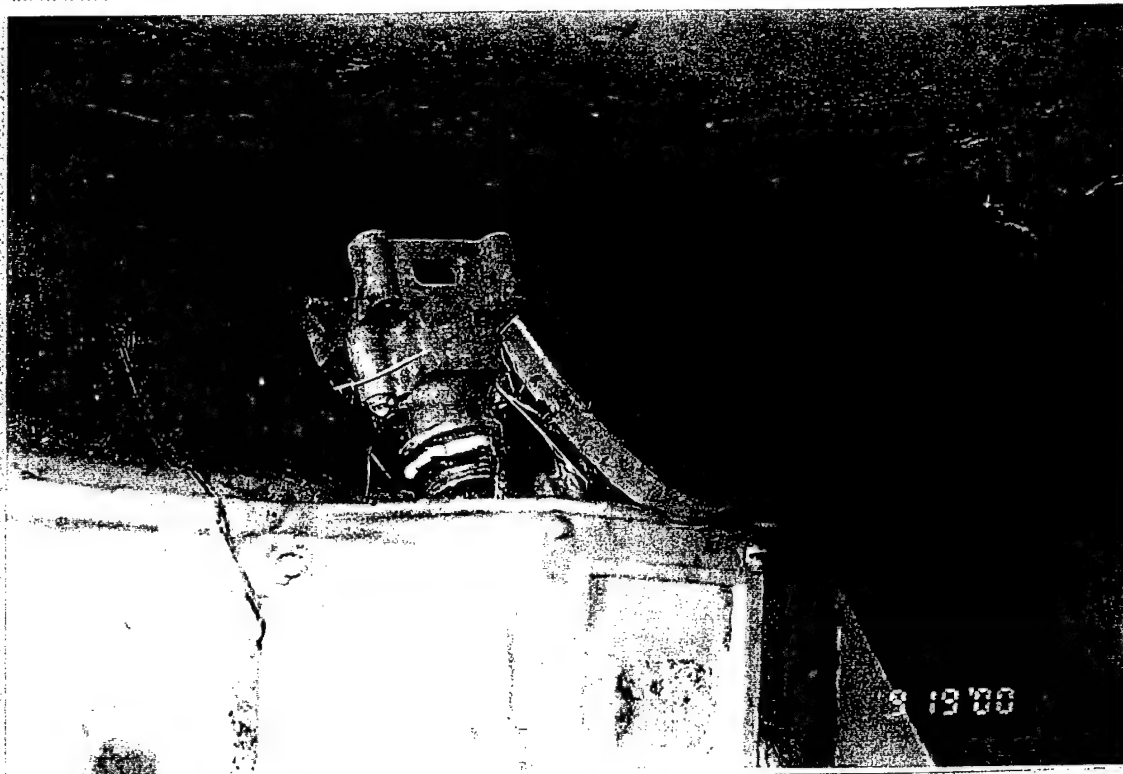
3-6

Gate 3 - 8'x18'
Left hoist reduction pulley. Note:
missing paint on pulley at previous
location of hoist connection.

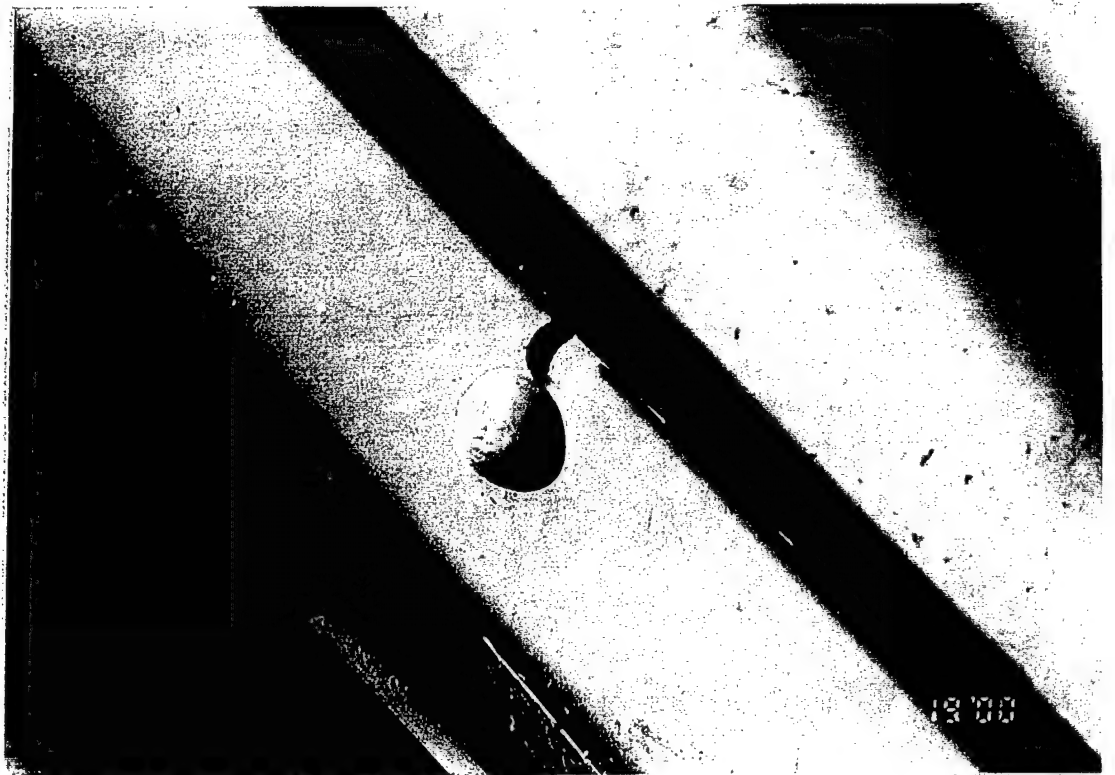
3-12

Gate 3 - 8'x18'
.Right trunnion, typical. Debris and
peeling paint in trunnion beam.

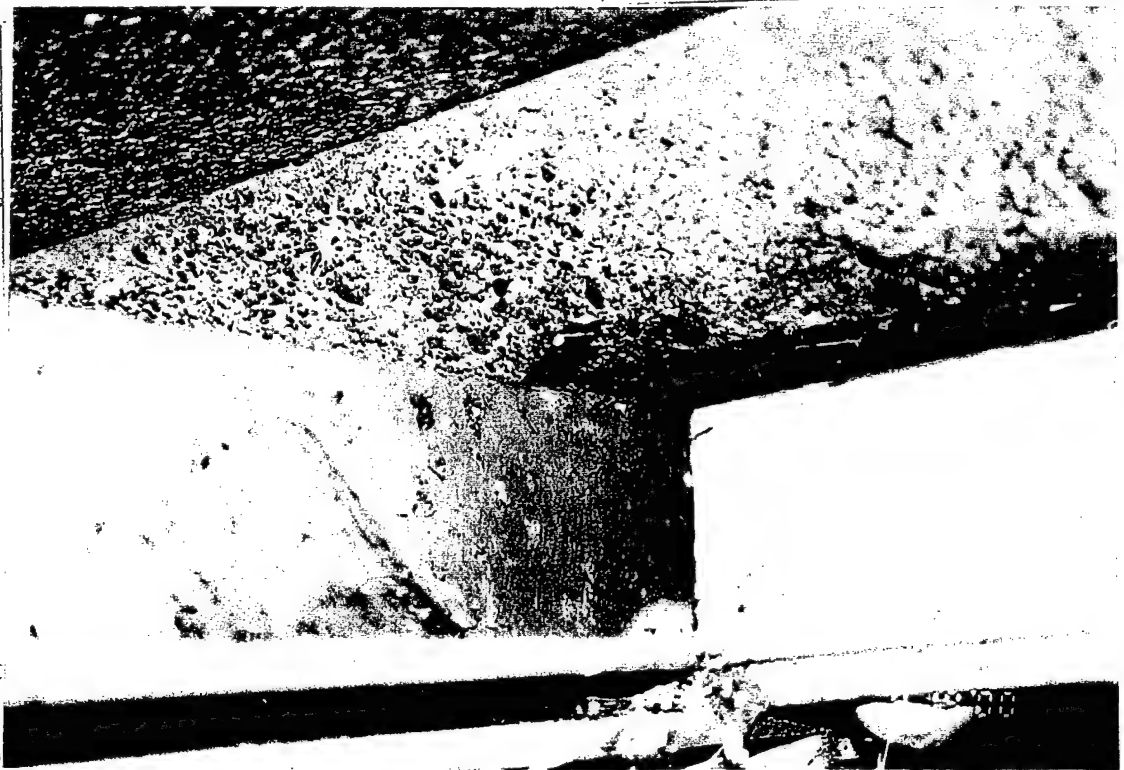
4-14

Gate 4 - 8'x18'
Right frame. Bottom strut and side
plate angle in contact with pier wall.
Note: steel ruler between strut and
pier.

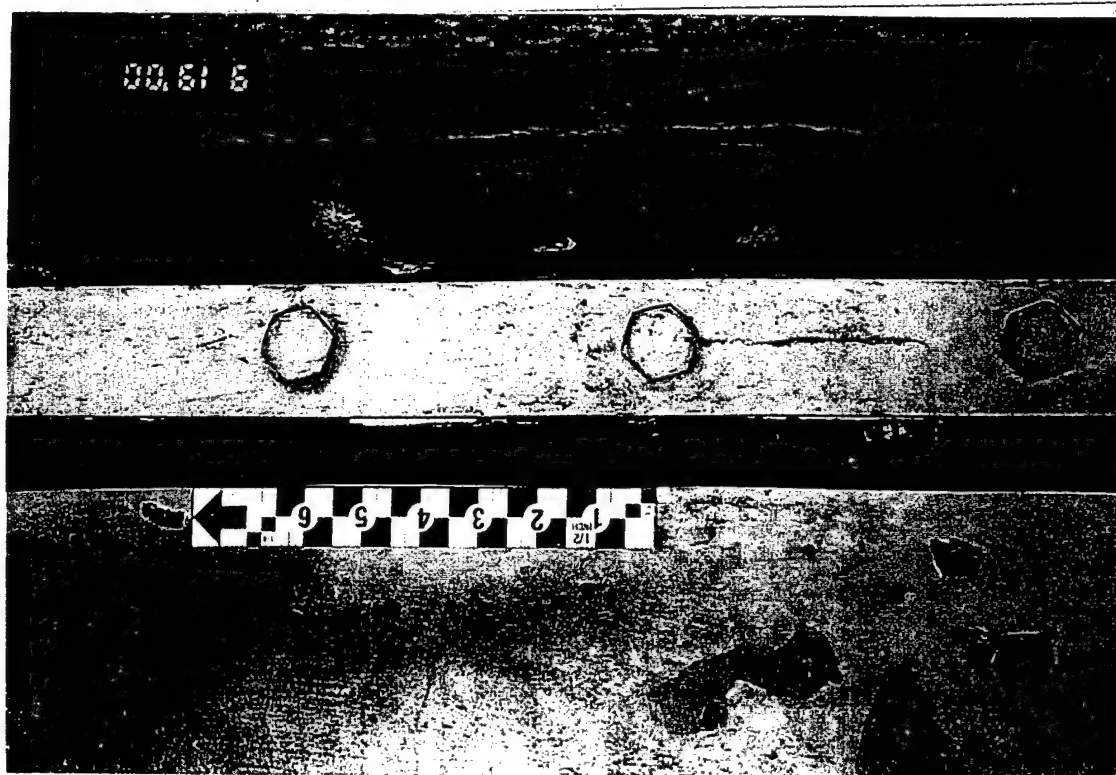
4-24

Gate 4 - 8'x18'
Side seal, typical.
